Manhole Inspection Summary

Manhole # S37CC_034MH

Location Address: **408 EAGER ST**

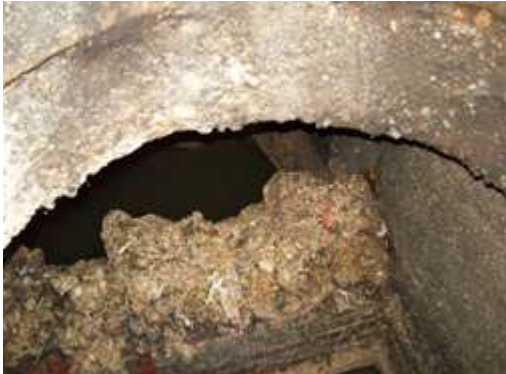
Defect 3

Surcharge ☒ **Evidence Of Surcharge** Depth: **11** (ft.) ☒ **Active Surcharge Present**

EVIDENCE OF SURCHARGE

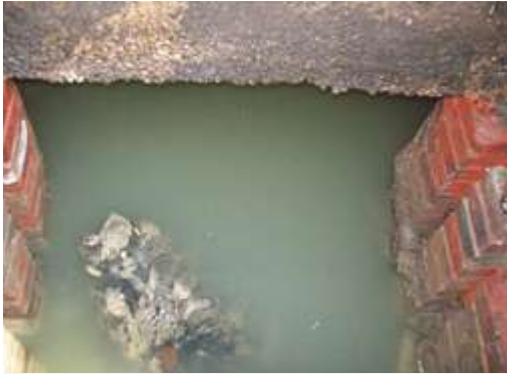
Defect 2

Frame Offset: **2** (in.) Condition: ☒ Sound ☐ Cracked ☐ Leaks

frame offset

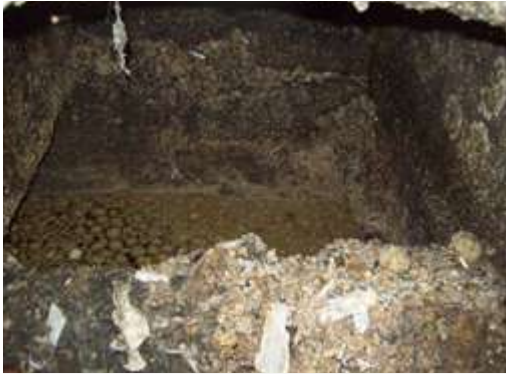
Defect 1

Comments **RIM TO INVERT 6B - 11.15FT, DOF - 50IN., SILT - 14IN.SIPHON WITH ACTIVE SURCHARGE 24/7. UNABLE TO DIVE.**

ACTIVE SURCHARGE
